Relatório de Investigação

**Acidente com o
veleiro MERI TUULI**

10 abril 2013

Relatório N.º 02/2013

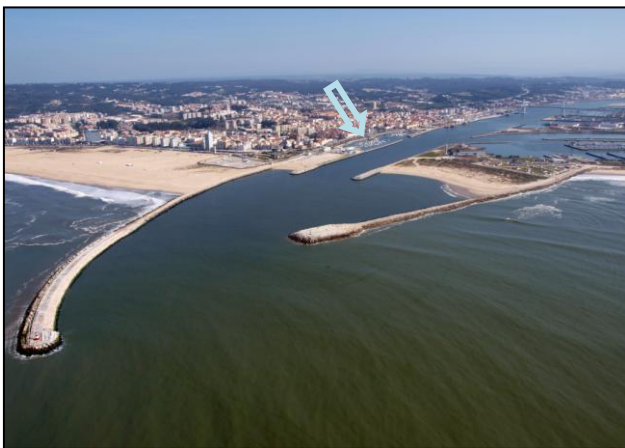
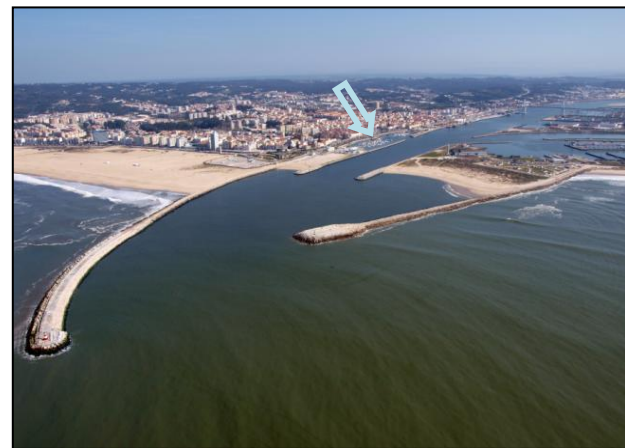
A barra do porto da Figueira da Foz é aberta aos quadrantes de oeste pelo que bastante vulnerável para as embarcações pequenas.

The harbour entrance of Figueira da Foz stretches and opens to the west quadrants being therefore very vulnerable to small vessels/sailing-crafts, specially with weather from W.

Figura 2: Barra do porto da Figueira da Foz

Figure 3: Harbour entrance of Figueira da Foz

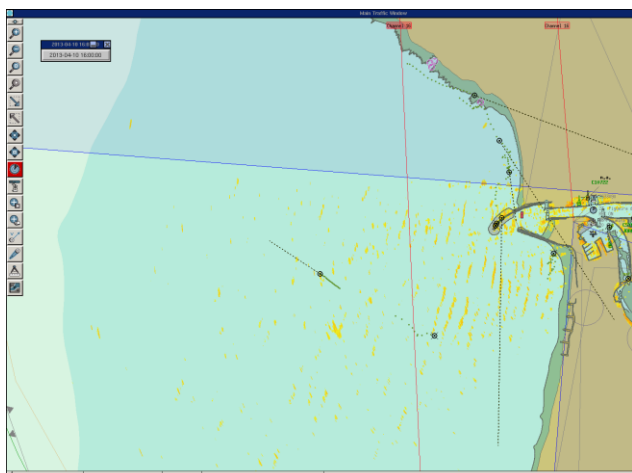
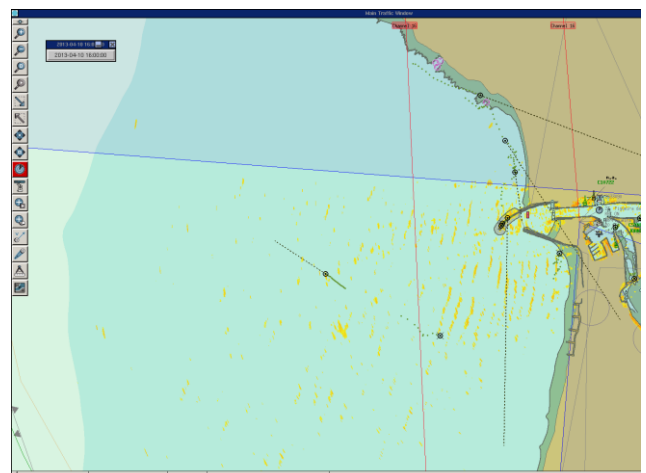
Figura 3: Imagem radar do VTS na zona da barra da Figueira da Foz às 16:00 onde é possível ver o estado do mar naquele local

Figure 3: VTS radar image of the Figueira da Foz harbour entrance at 16:00 where it is possible to see the swell around
